Libby Asbestos Site

Libby, Montana

Initial Soils Data Gap Sample Collection
Operable Unit 5 - Former Stimson
Lumber Mill Site

Draft Sampling &
Analysis Plan Addendum

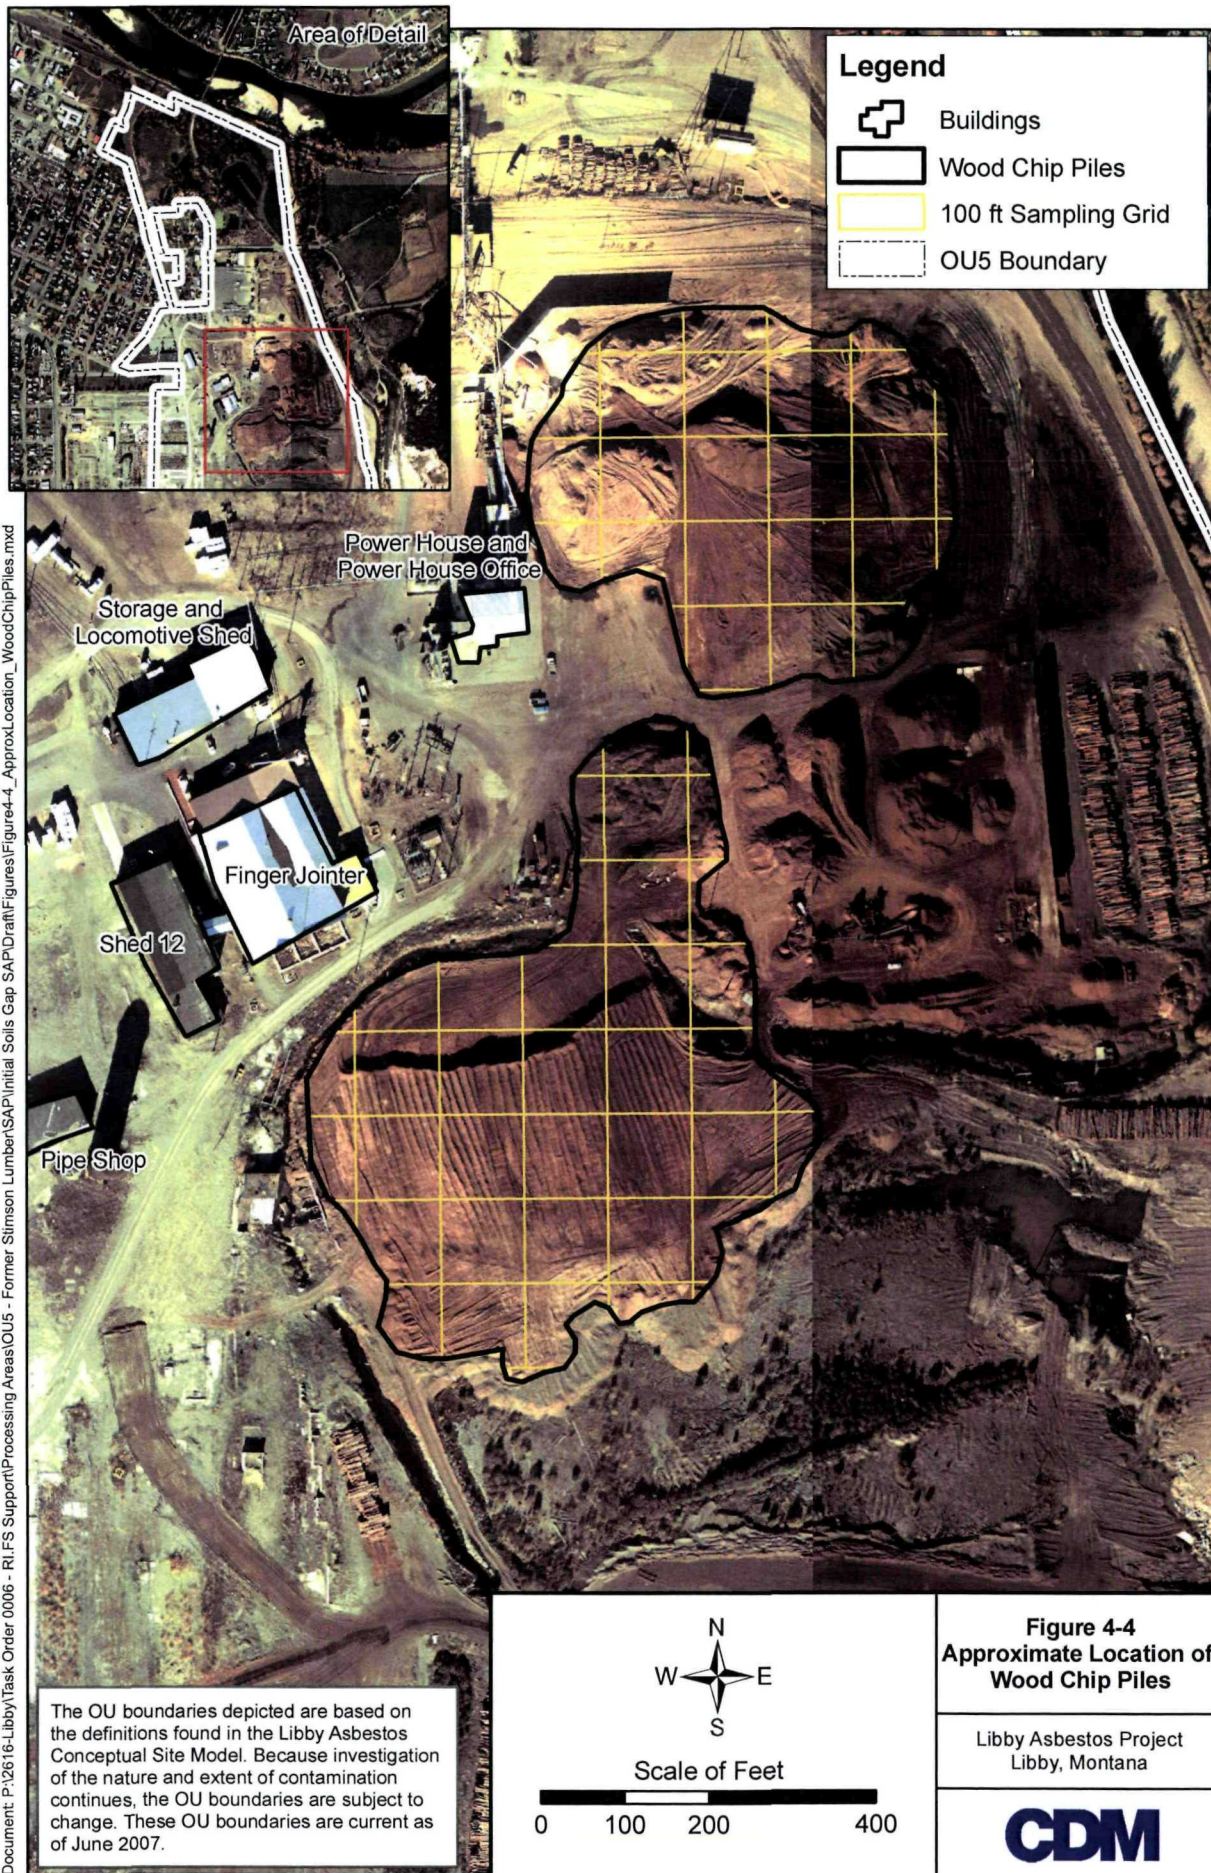
Document: P:\2616-Libby\Task Order 0006 - RI FS Support\Processing Areas\OU5 - Former Stimson Lumber\SAP\Initial Soils Gap SAP\Draft\Figures\Figure4-5_FomerNursery_ShedAreaWGrids.mxd

Located near the center of the former nursery area and situated around the previous sampling locations (CS-09595, CS-09672, SQ-00067, and SQ-00066) is an area where LA has been found at trace concentrations (less than 0.2 percent). This area will be divided into a 100 foot by 100 foot grid system (Figure 4-6). One 30-point composite surface soil sample will be collected from each grid and a visual estimation inspection completed for each sample aliquot.

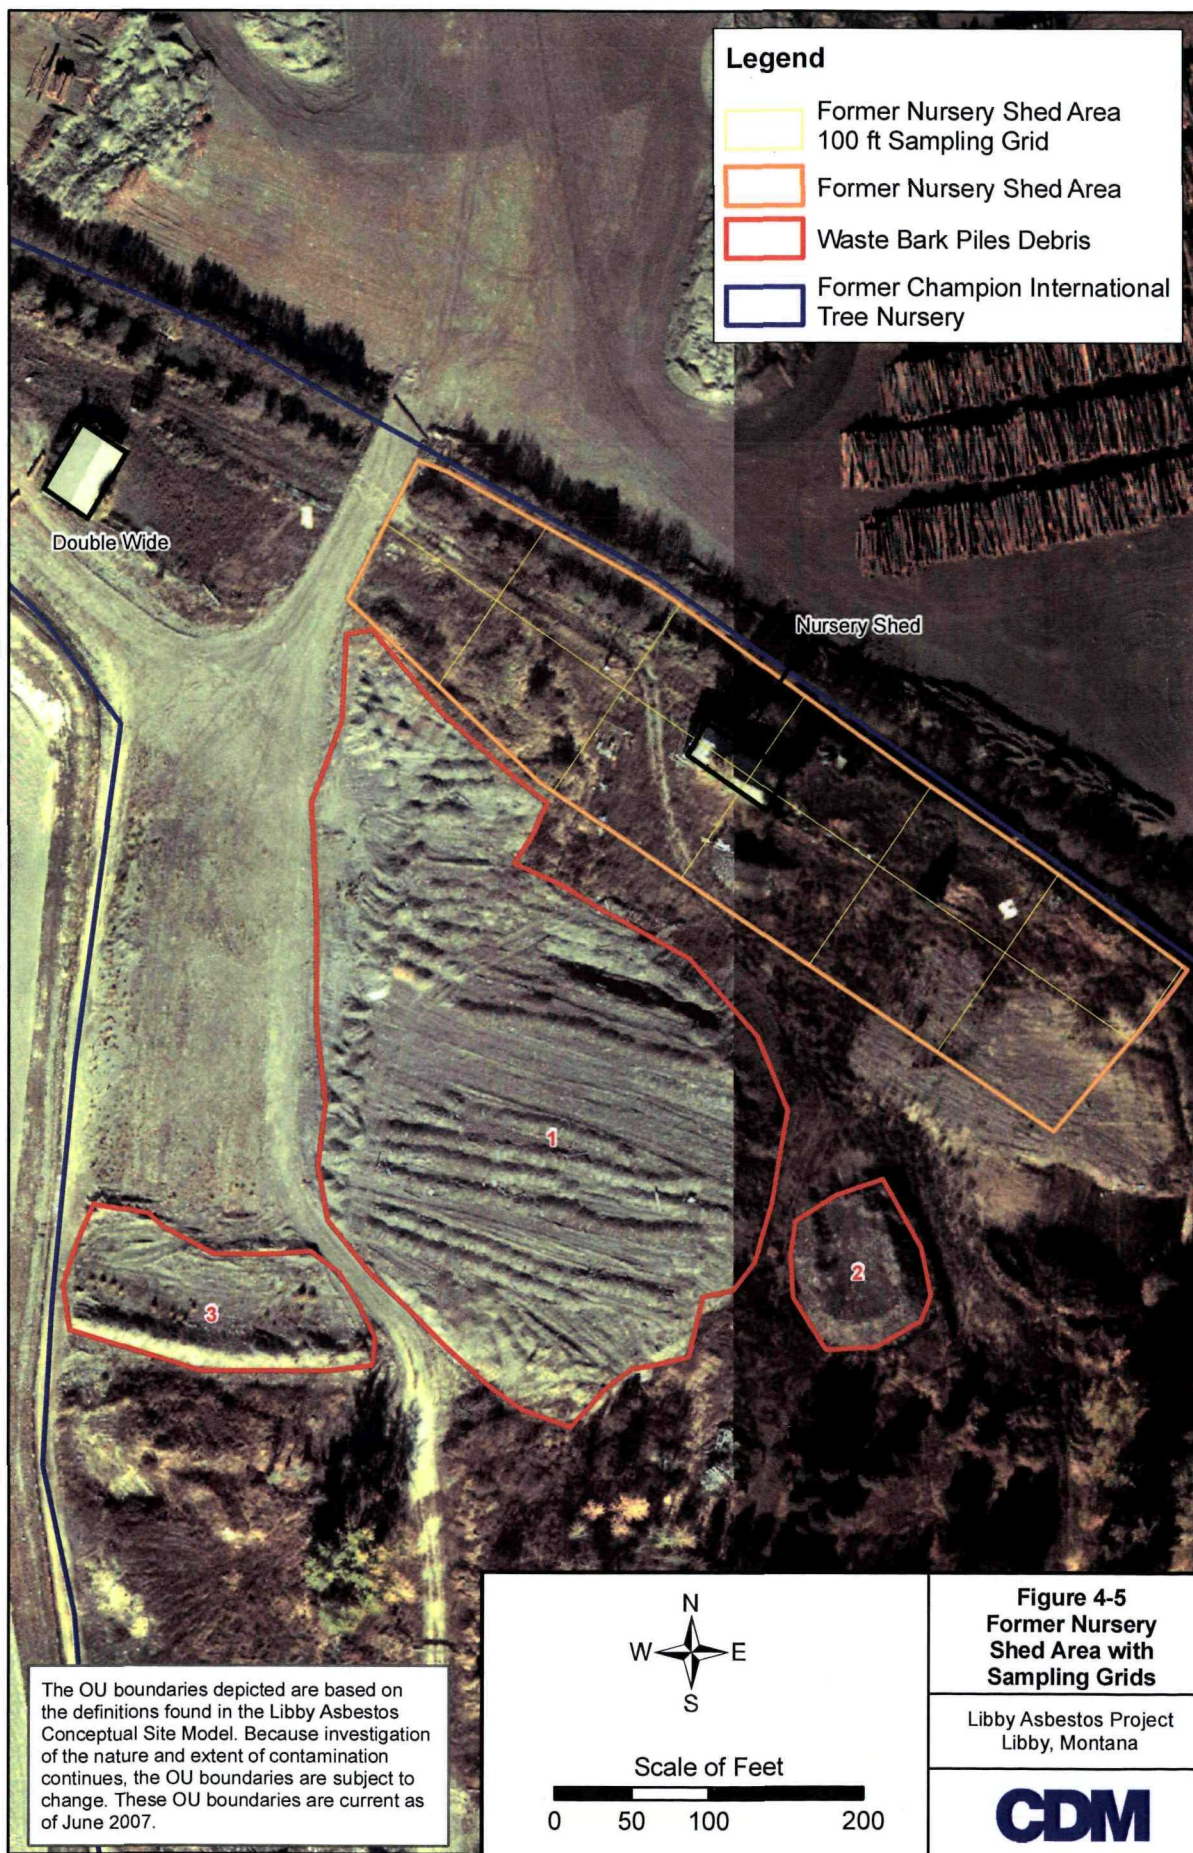
Soil and dust samples collected near the former nursery shed have shown high levels of detectable LA in previous sampling events. Therefore, additional soil sampling and a visual vermiculite evaluation will be conducted in this area. One 30-point composite surface soil sample will be collected from each 100 feet by 100 feet grid in this area (Figure 4-5) and a visual estimation inspection completed for each sample aliquot.

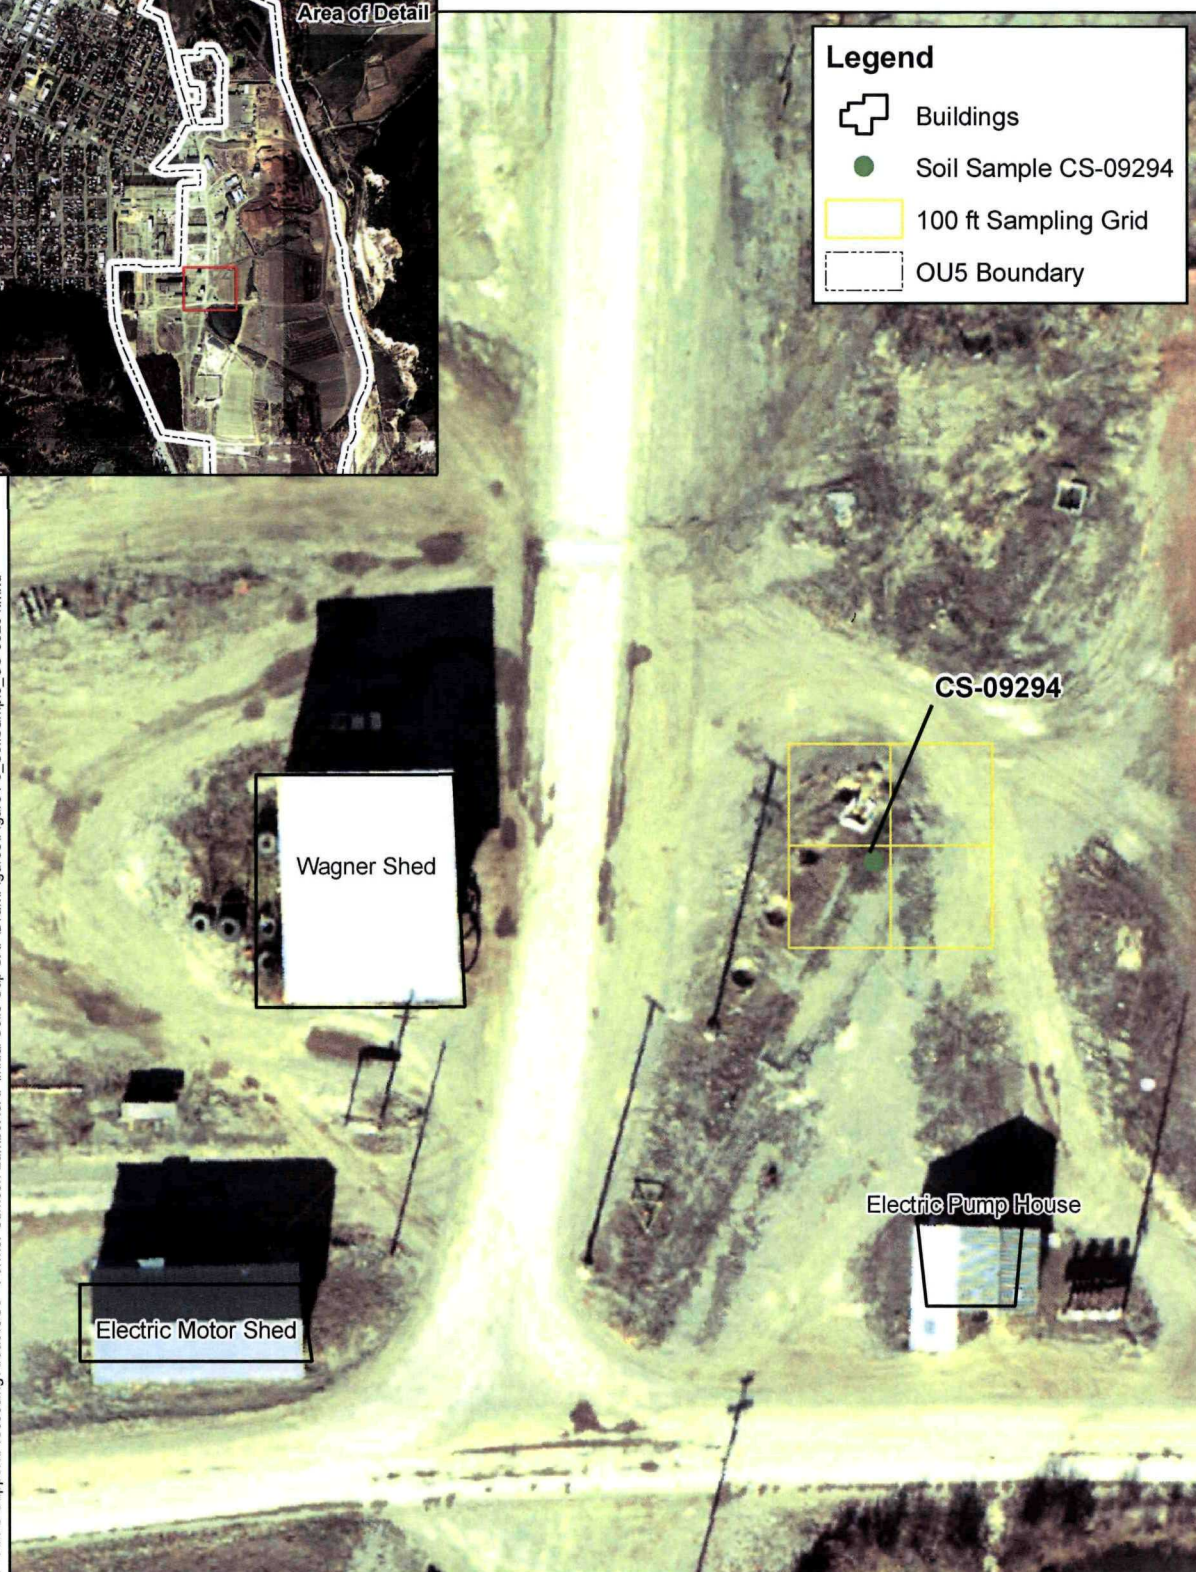
-   Buildings
-   Soil Sample CS-09294
-   100 ft Sampling Grid
-   OU5 Boundary

Document: P:\2616-Libby\Task Order 0006 - RI\FS Support\Processing Areas\OU5 - Former Slimson Lumber\SAP\Initial Soils Gap SAP\Draft\Figures\Figure4-8_SoilSample_CS-09294.mxd
